Upper East Branch White Clay Creek Watershed Assessment Report

West Marlborough Township, New Garden Township, London Grove
Township, and Avondale Borough, Chester County,
White Clay Watershed, Pennsylvania

July 6, 2023

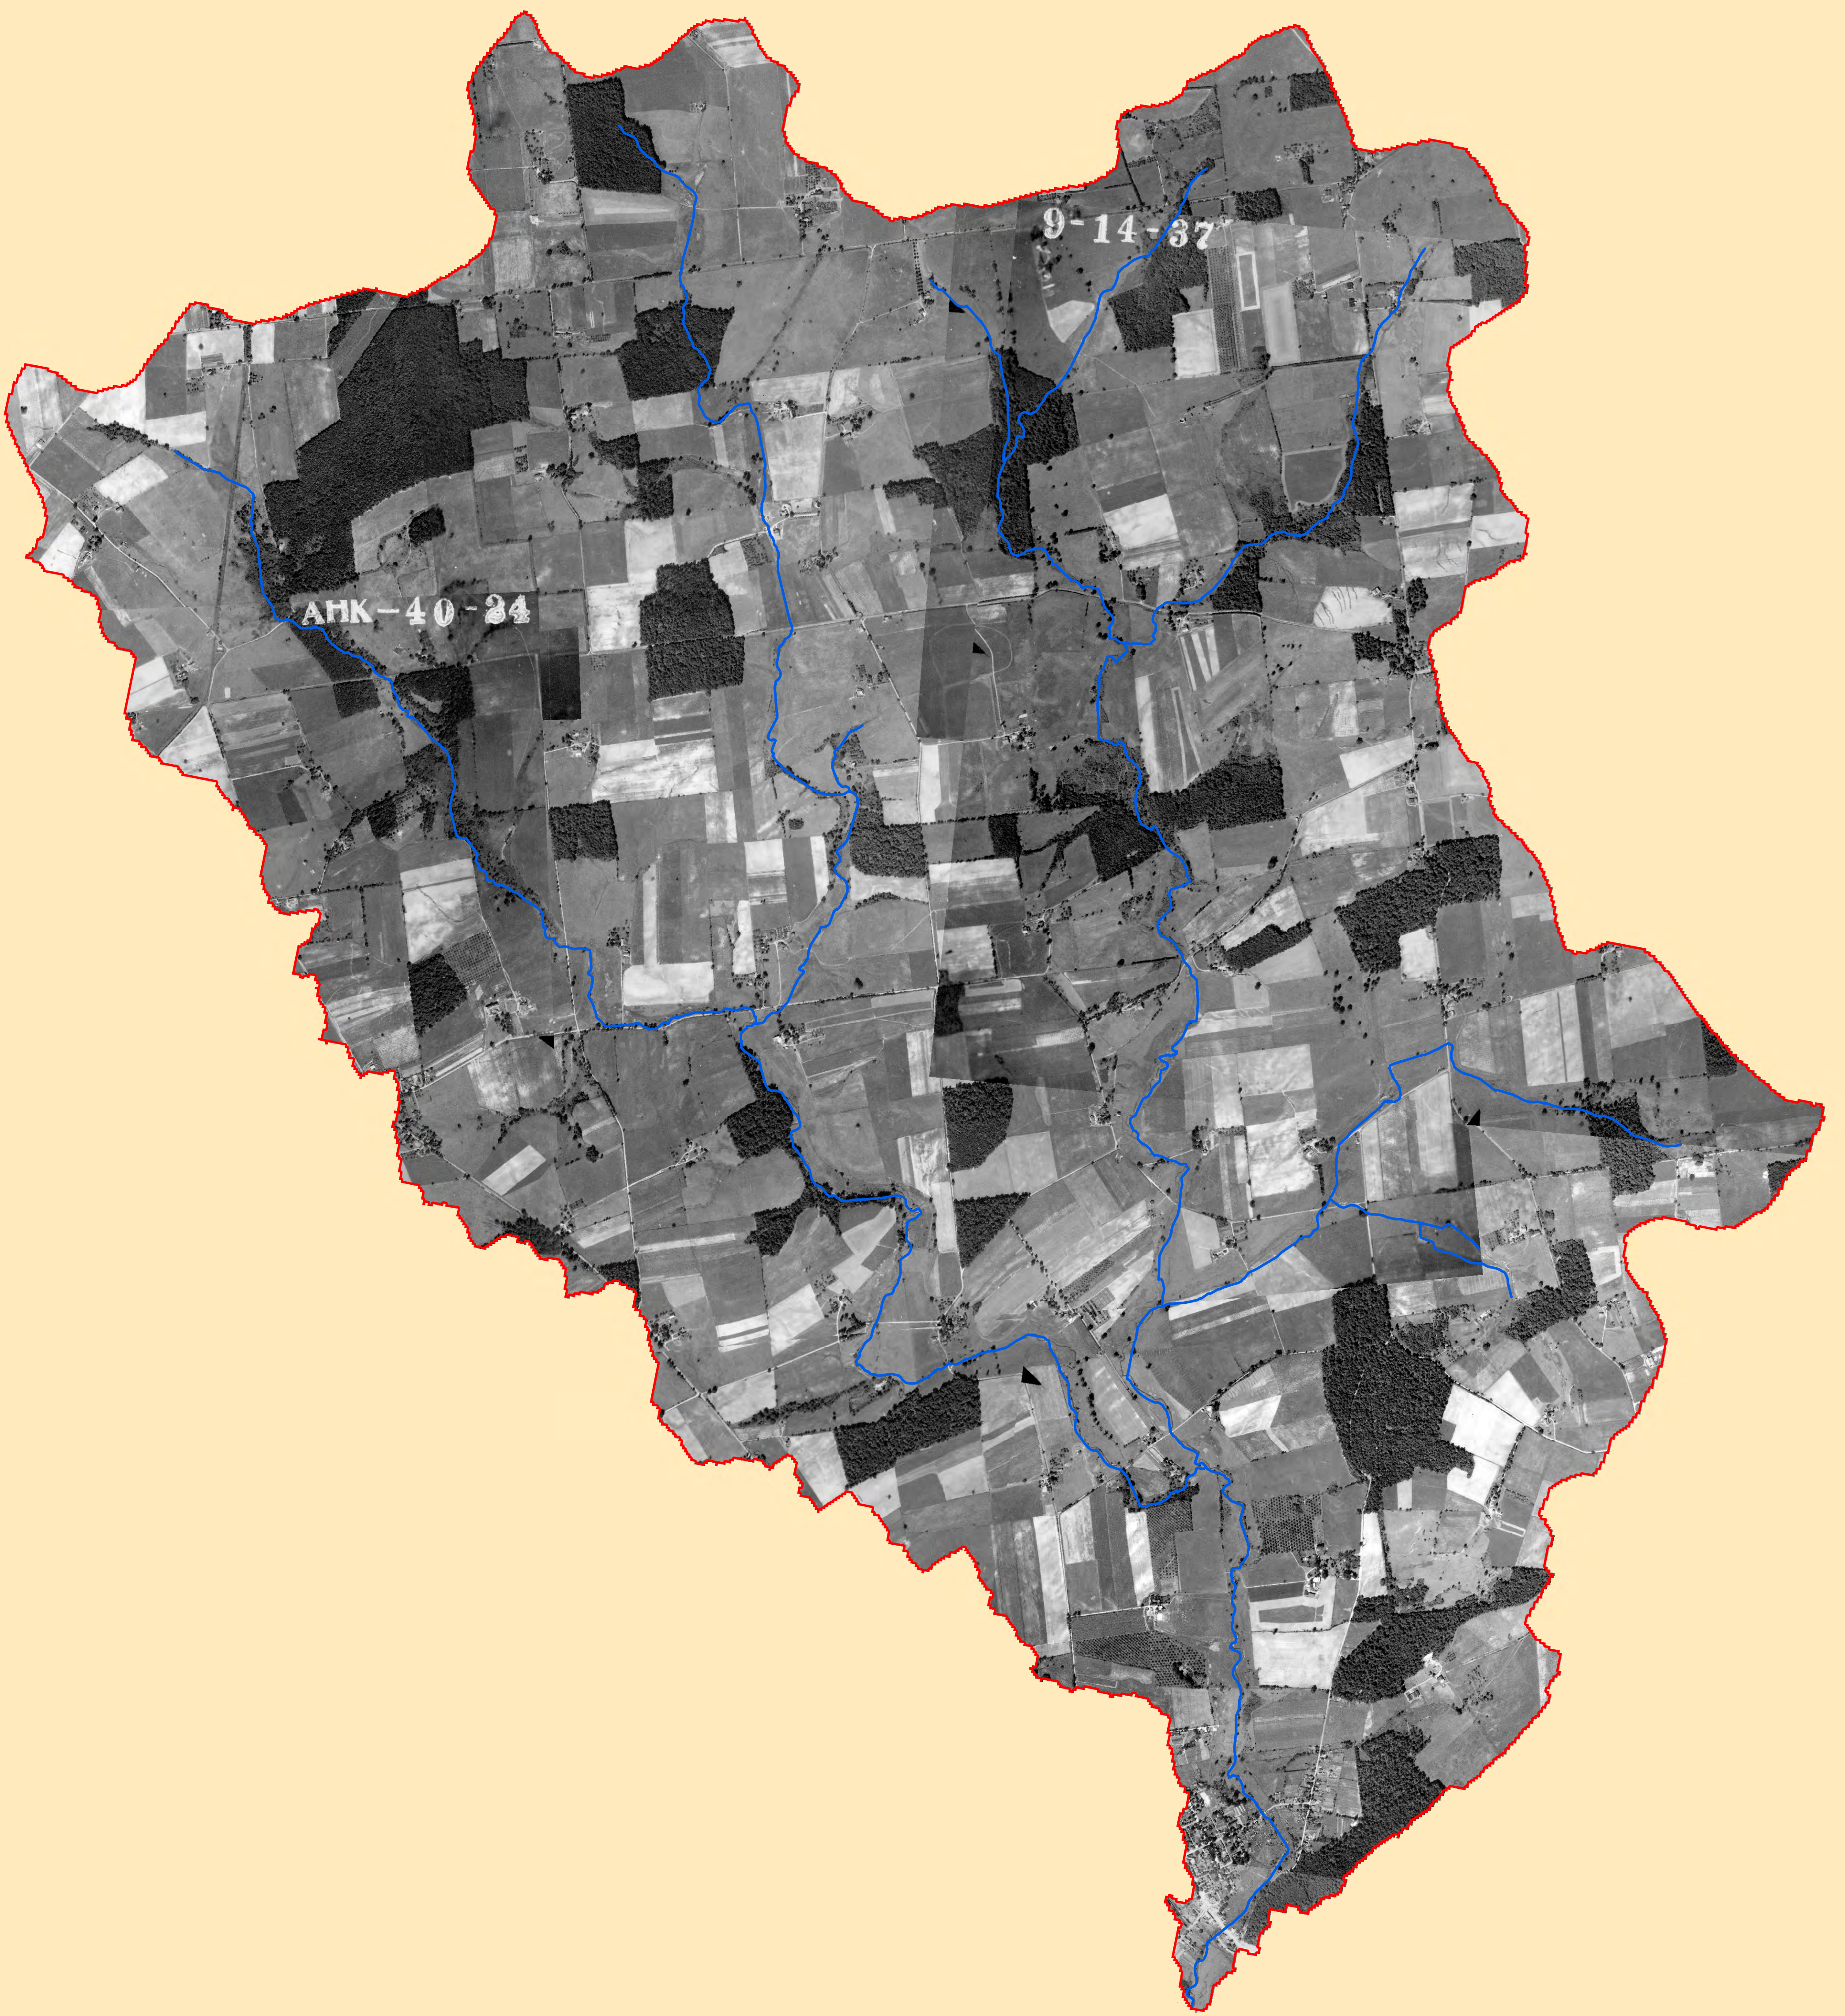
**Upper East Branch White Clay Creek
1937 Aerial Photography
Chester County, Pennsylvania**

zone habitat was considered optimal, and the macroinvertebrate study identified 38 different taxa within the sample. Since 1937, the forested cover upstream of Sample Site 10 has continually increased (Appendix B). Preservation of the water quality and habitat conditions of this headwater area that provides a refuge for sensitive species within the watershed should be a high priority for conservation organizations within the watershed. Downstream of Sample Site 10, Trib 00455 runs through mostly forested corridors that are surrounded primarily by agricultural fields. Historically, the lower portion of this sub-watershed was cleared for agricultural. Since 1971, substantial regrowth of trees within the riparian zone has occurred. But, the legacy impact of sediment within the riparian zone disconnects the stream channel from an active floodplain. The legacy sediment is actively eroding into the stream channel and continues to impair this stream section (Sample Site 9 in Table 3). Restoration of the section of Sub-watershed H downstream of Sample Site 10 should focus on reconnecting the stream channel to the active floodplain by removing legacy sediment within the riparian zone, installing floodplain wetlands, expanding the riparian forested buffer, and stream restoration that incorporates the removal of legacy sediment to achieve a stable, vegetated slope.

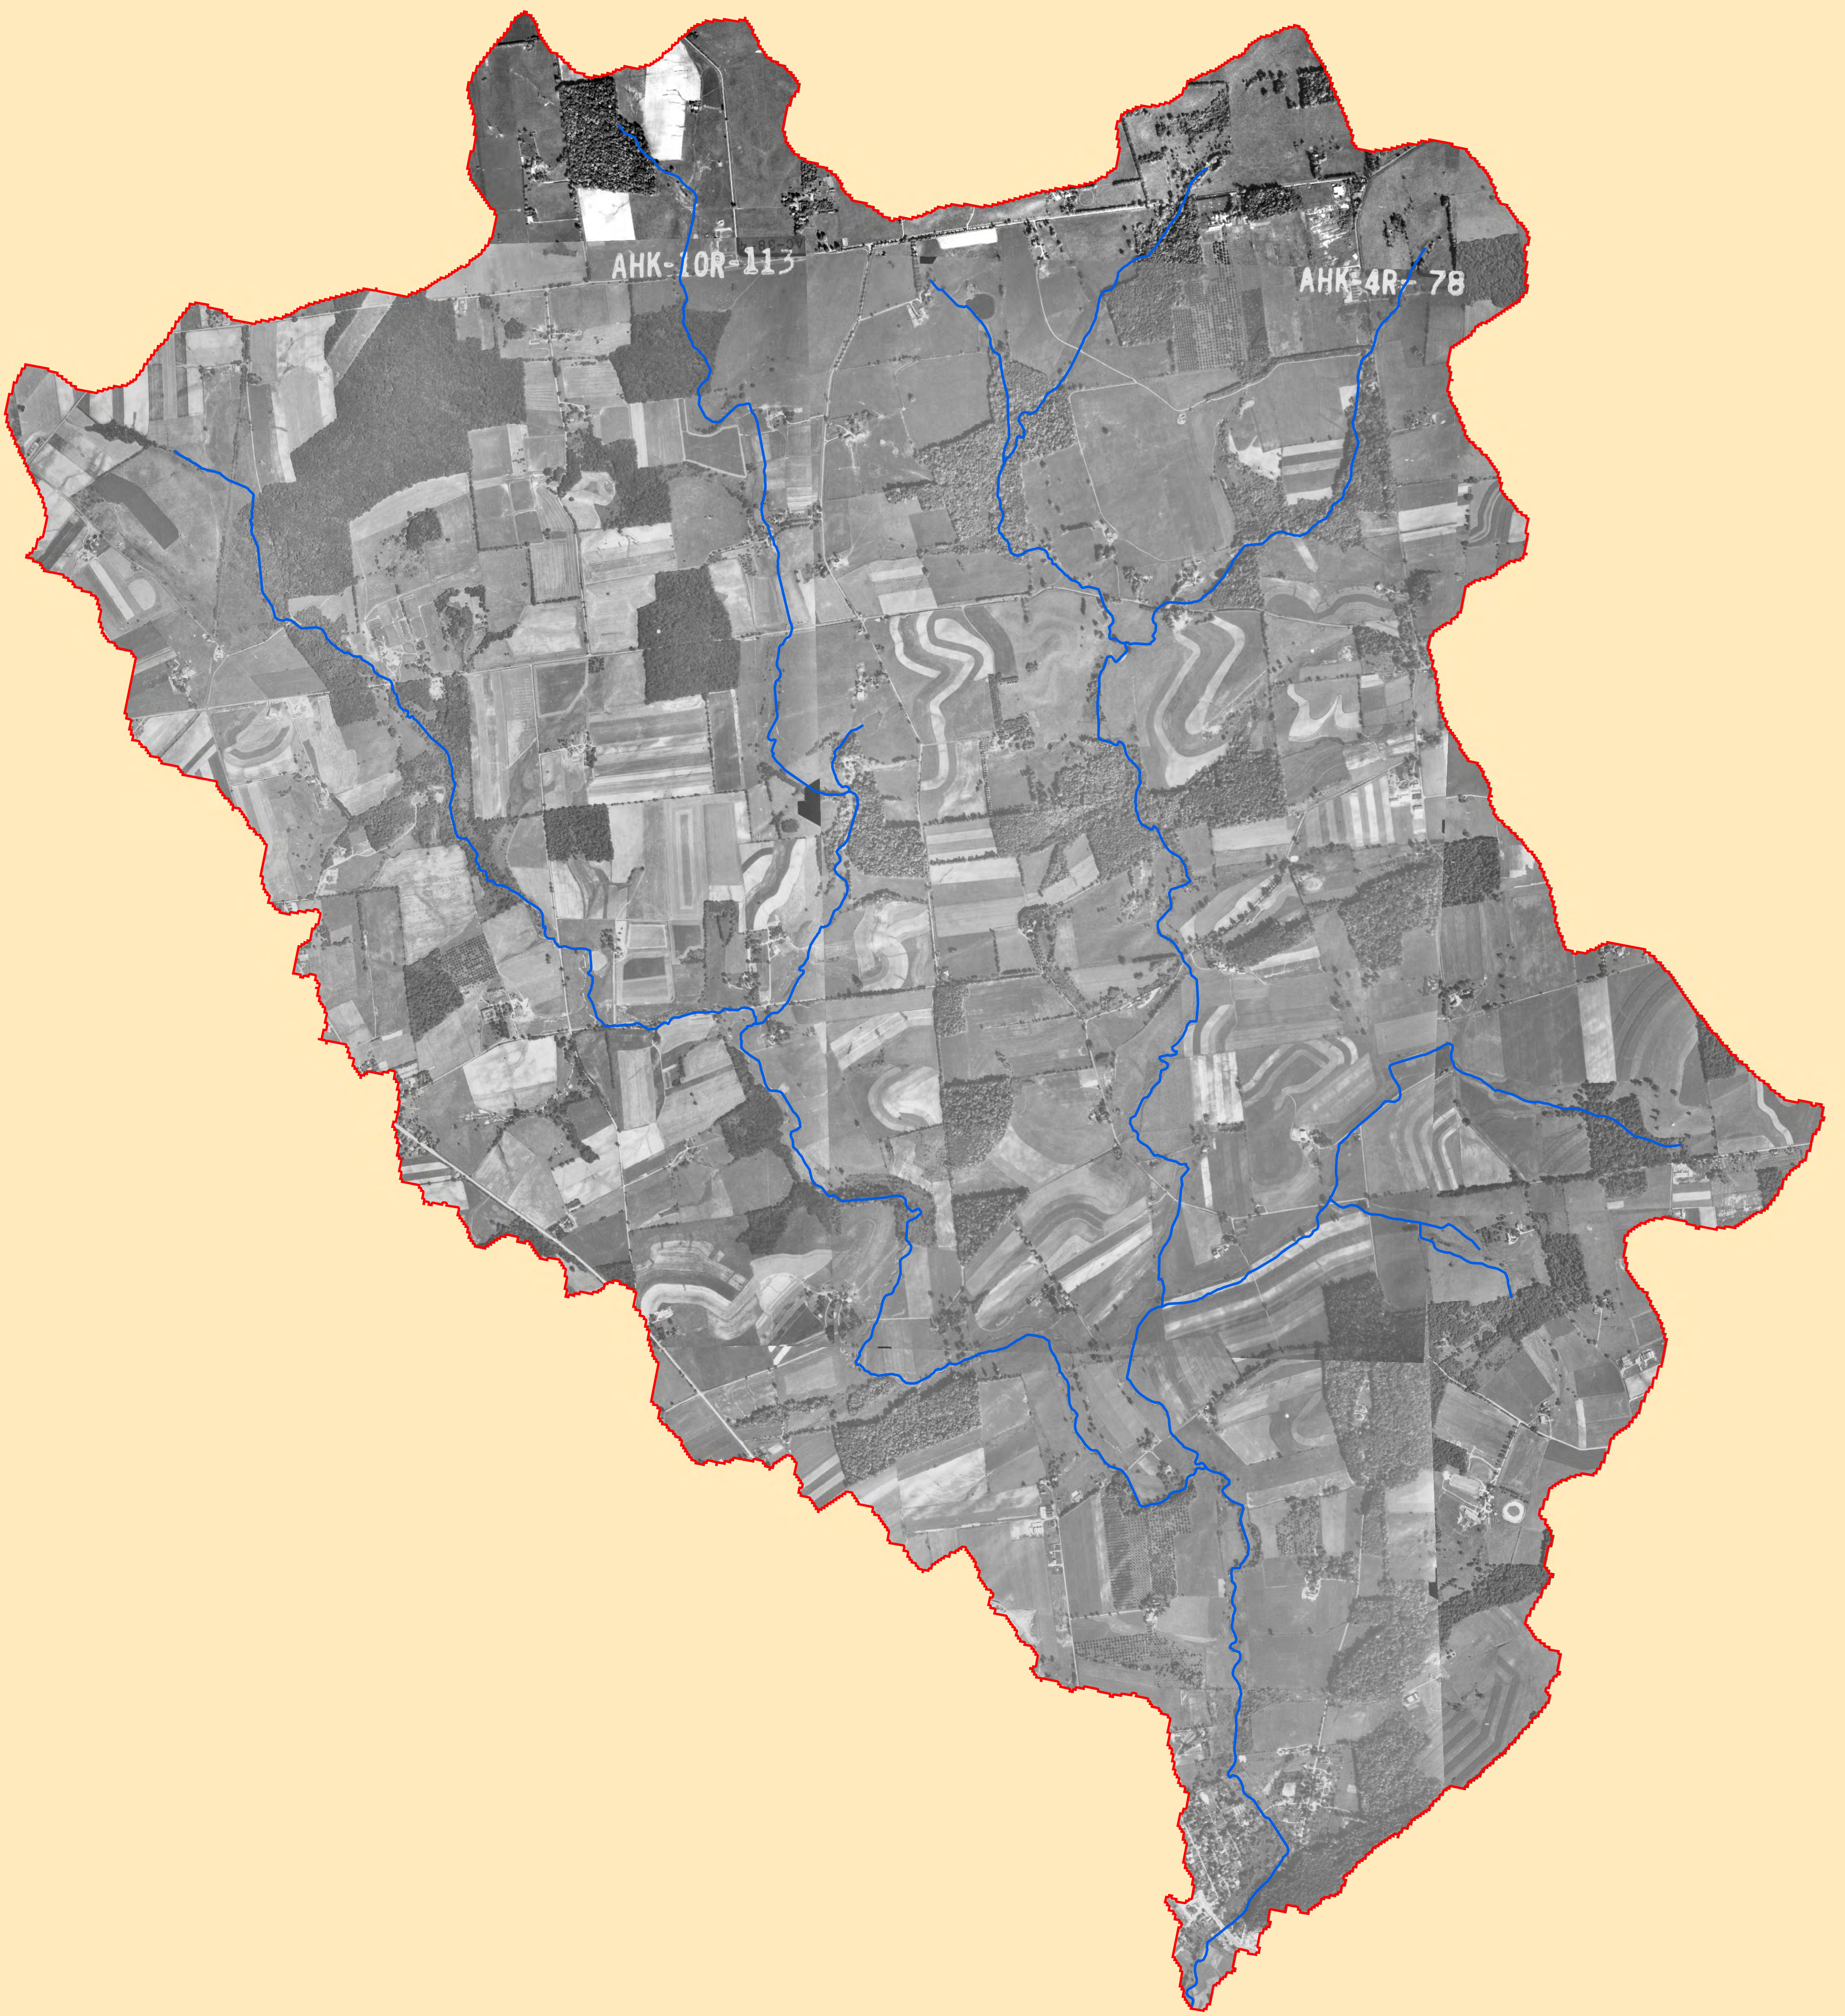
**Upper East Branch White Clay Creek
1957-58 Aerial Photography
Chester County, Pennsylvania**

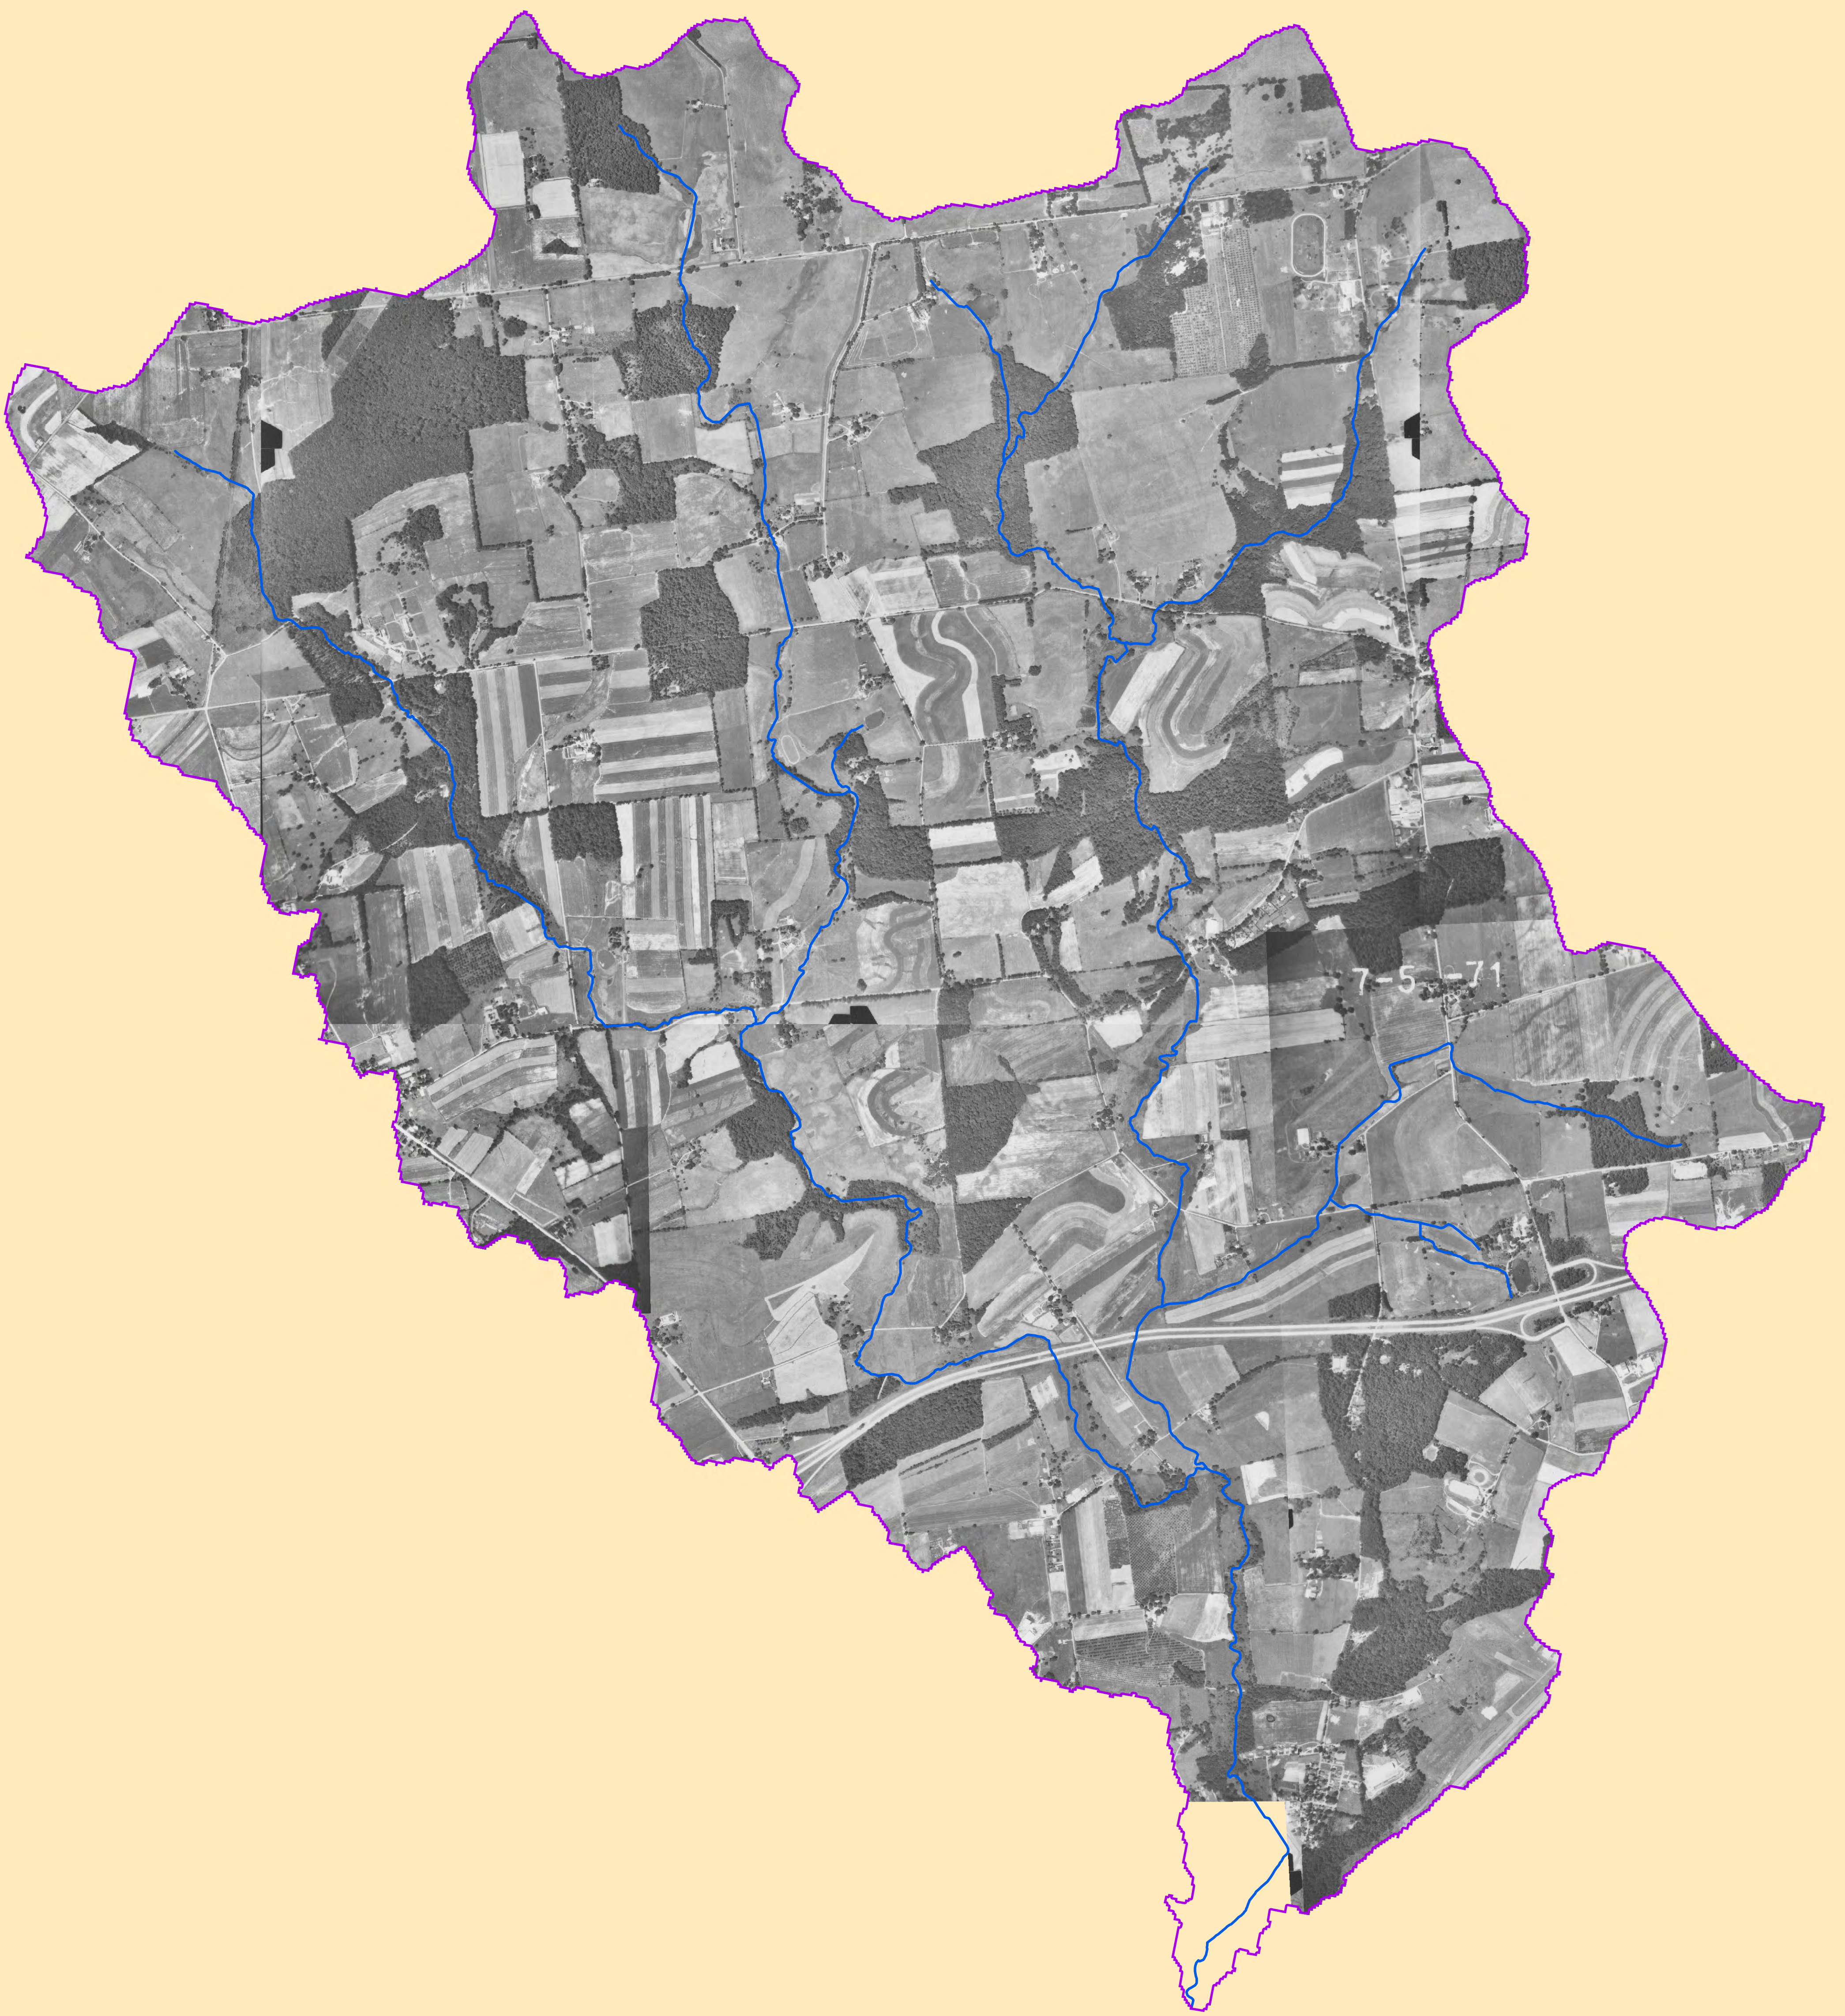
Upper East Branch White Clay Creek 1971 Aerial Photography Chester County, Pennsylvania
