Upper East Branch White Clay Creek Watershed Restoration Plan

West Marlborough Township, New Garden Township, London Grove
Township, and Avondale Borough, Chester County,
White Clay Watershed, Pennsylvania

July 27, 2023

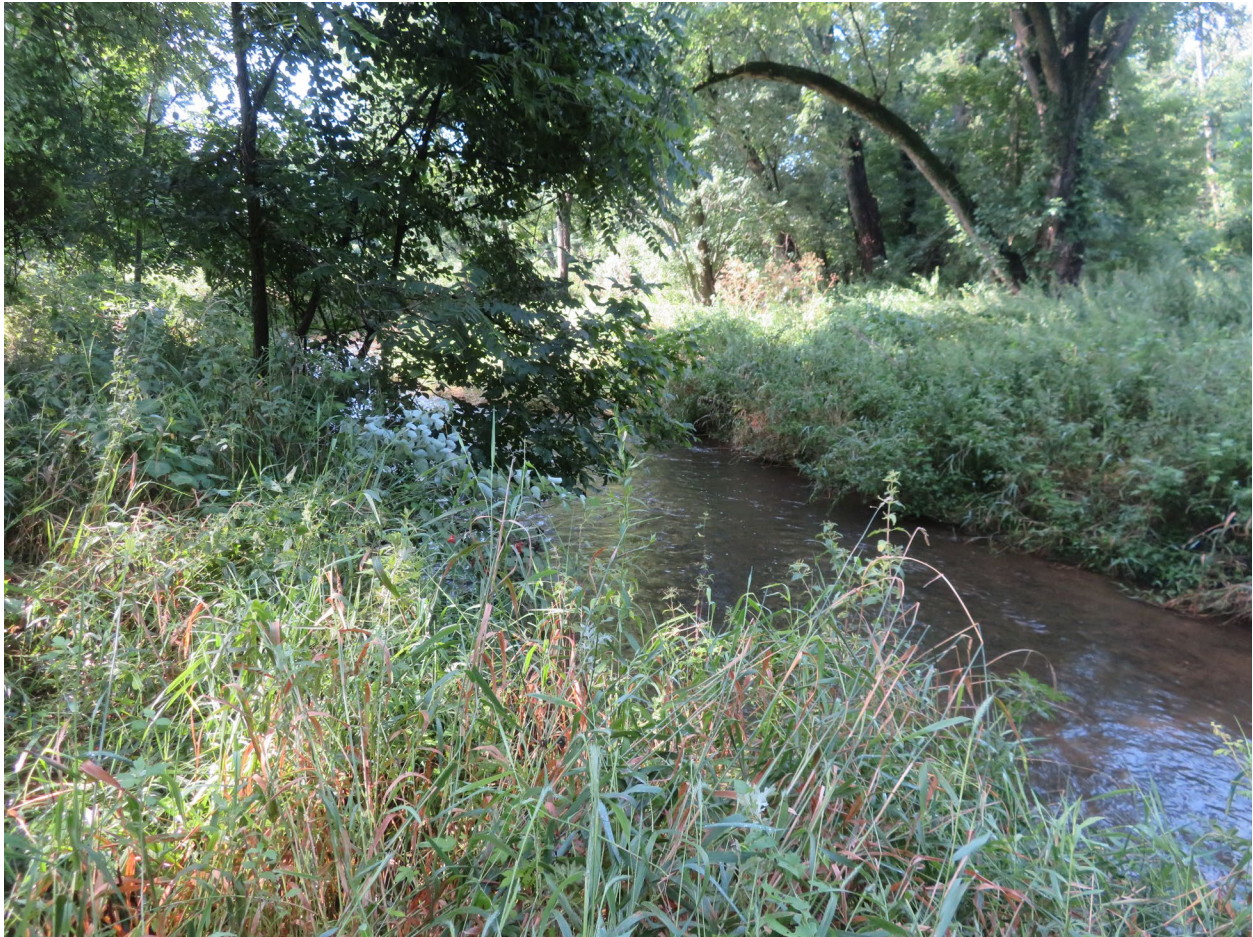
Impacted Stream Segment #1:

Invasive species including stilt grass (*Microstegium vimineum*), poison hemlock (*Conium maculatum*), Japanese knotweed (*Reynoutria japonica*), multiflora rose (*Rosa multiflora*), Japanese hops (*Humulus japonicus*), reed canary grass (*Phalaris arundinacea*), porcelain berry (*Ampelopsis brevipedunculata*), mugwort (*Artemisia vulgaris*), Asiatic bittersweet (*Celastrus orbiculatus*), and others dominate this section of the watershed and many others. Invasive species outcompete native plant species and often provide less desirable habitat conditions for other species within the watershed. This high priority project includes the entire watershed.

Restoration of the watershed should include the removal of invasive species. For each area where the invasives are removed, the need for planting of native species as replacements should be considered. Typically, removal of the invasive species within this watershed will include selective herbicide application on multiple occasions. Within the watershed as a whole, restoration projects should include a longterm maintenance plan that includes managing invasive species with an integrated pest management plan approach.

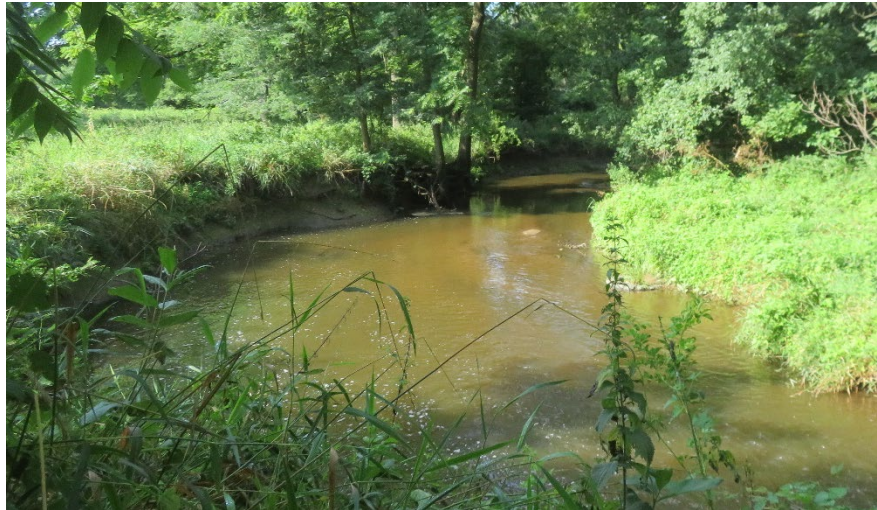
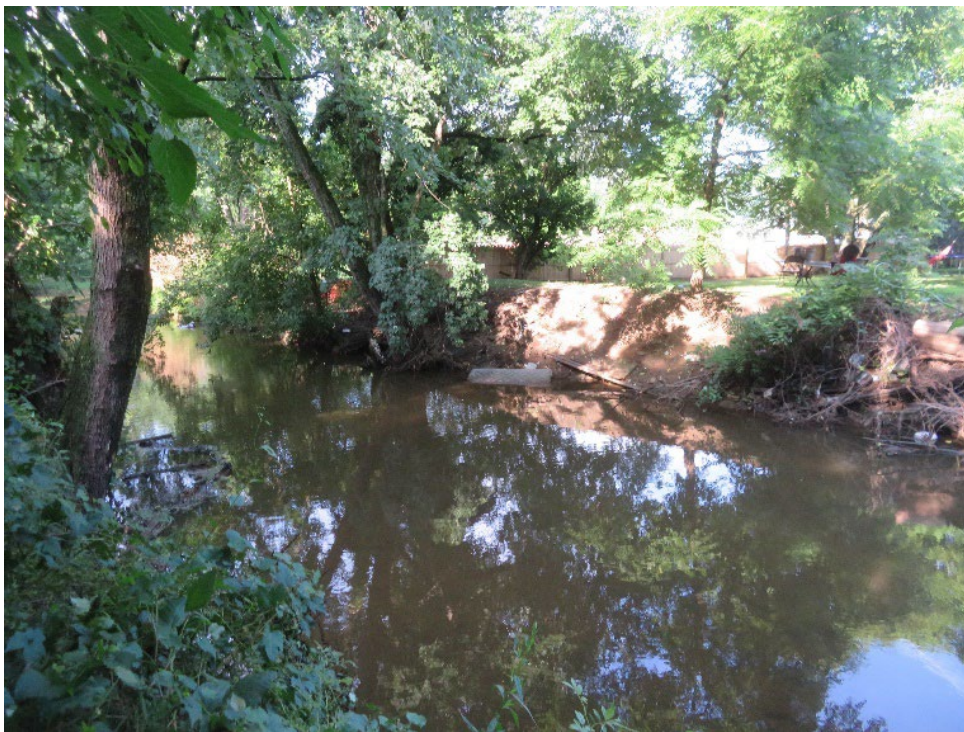
Impacted Stream Segment #2-4:

Within this section of stream, the streambanks are actively eroding and are between 4 and 5 feet high. This height disconnects the stream from the active floodplain. Some areas are mowed to the top of the streambank. Large pieces of flood debris and litter are within the channel and on the floodplain. Throughout this stream section and the older areas within the Borough of Avondale, there is a lack of control of stormwater discharging to the stream from impervious areas within commercial areas, roadways, and residences.

Restoration of this stream segment should focus on restoring the floodplain by removing legacy sediments on the eastern side of the stream to create an active floodplain that is more closely tied to the stream channel. The new floodplain should include wetland

pockets to improve the habitat diversity and flood water retention of the site. Creating a more gradual slope for the streambanks on both sides of the channel and then stabilizing them with native vegetation will allow for this section of the watershed to filter pollutants and absorb some of the flooding flows. The

incorporation of natural stream design structures such as j-hooks, rock vanes, root wads, and deflectors in the project plan will aid in stabilizing the streambanks during vegetation establishment and creating diverse habitat areas. Ongoing maintenance of this area should incorporate litter cleanups and invasive species removal.

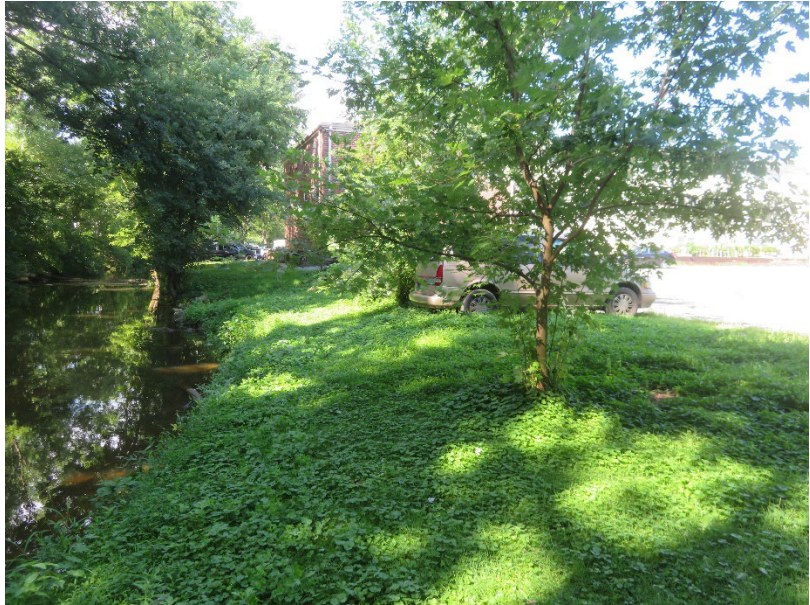
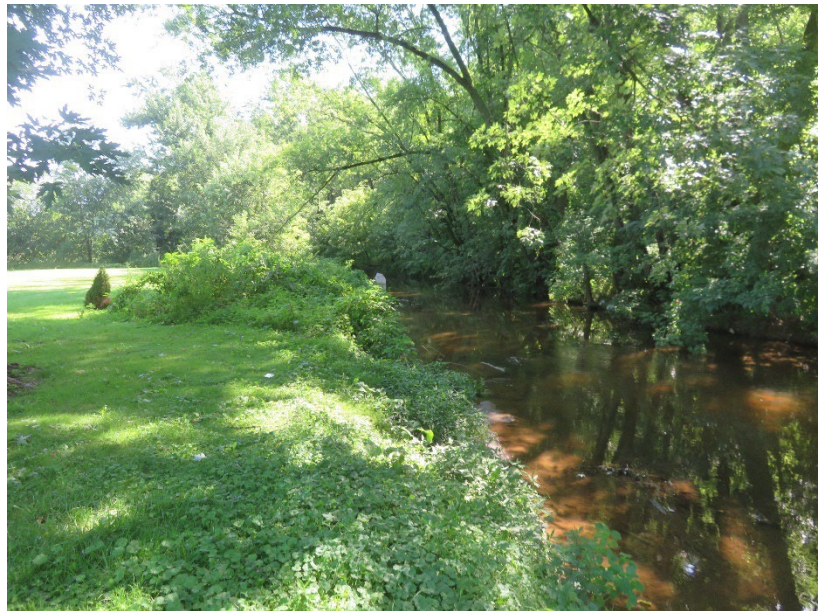
Impacted Stream Segment #6-8:

Within this section of the stream, businesses and residences along the northwestern streambank are routinely flooded. Stormwater from the surrounding area discharges into the stream without control, and the streambanks are mowed to the edge in some areas. Directly upstream of this point is park property, a section of which has stable banks and a well-connected floodplain.

After careful consideration and communication with watershed stakeholders, Clauser Environmental proposes that the best long-term solution to the impacts of the flooding in this part of Avondale is likely a FEMA buyout of the impacted properties. Even with all of the recommendations from this watershed restoration plan implemented, it is unlikely that the properties within the floodplain of this stream segment will be spared from future flooding. It is a matter of when, not if, the properties will flood again. With global climate change increasing the frequency and magnitude of flood events, the impacts to this area will likely increase in the foreseeable future. This buyout is recommended as being contingent on the establishment of additional low-income housing options within or near the Borough of Avondale and the provision of necessary assistance to help current residents with relocation. The area could be converted into a passive public park that could be a centerpiece for outdoor recreation within the community. By limiting infrastructure within the floodplain, future risks to residents and property will be limited. As the area is naturalized, the streambanks and riparian zone should be planted with native vegetation.

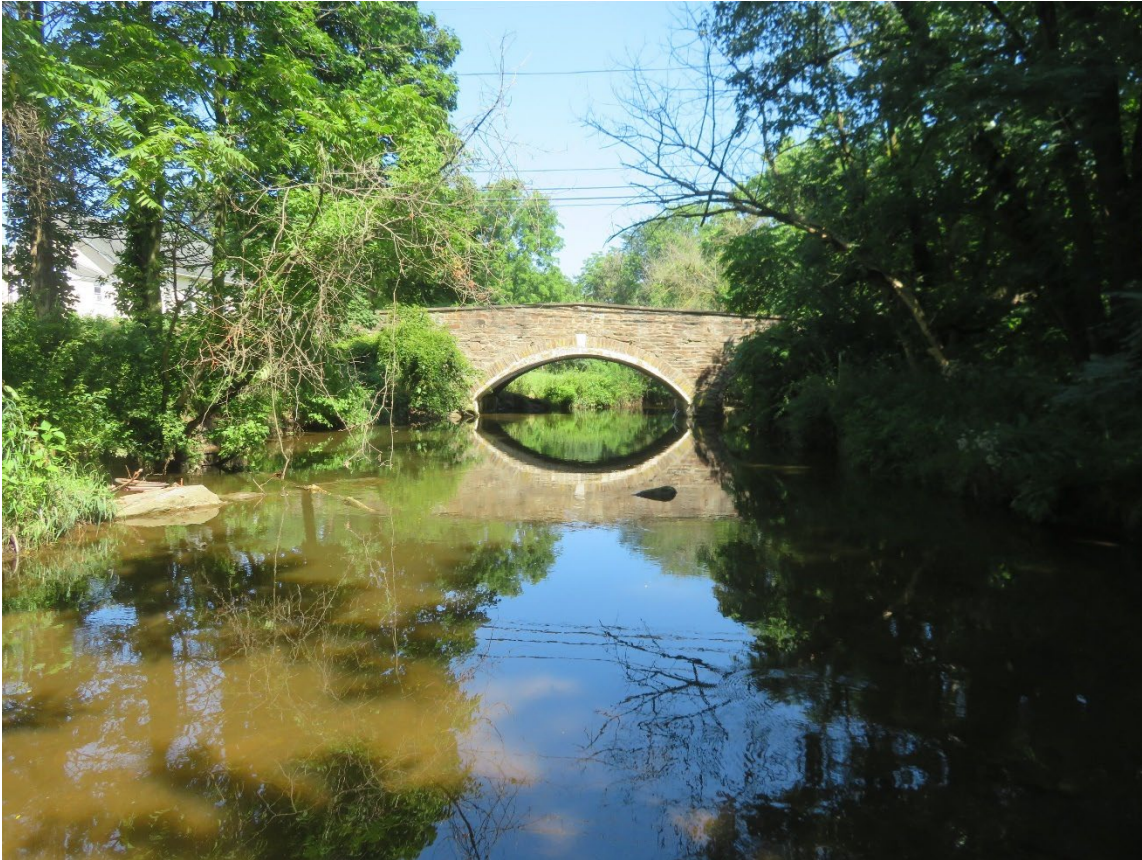
Impacted Stream Segment #11:

Within the lower section of the Upper East Branch White Clay Creek watershed, substantial flooding has repeatedly occurred. Residents, business owners, public officials, and first responders lack a reliable notification system for flooding within the watershed. When flooding occurs, there is an immediate need to rescue residents from the floodwaters, sometimes with boats. During the flooding and while work is done to repair the damaged areas, approximately 140 residents need to be housed in temporary shelters.

This high priority project focuses on protection of life and property from future flooding events within the watershed. The USGS stream gauge at this location could be coupled with long-term data from flow measurements Stroud Water Research Center and others have taken in the headwaters to develop a flow model for flooding in the watershed. By linking the stream gauges with precipitation data and forecasts, it is possible to develop an early warning system for flooding that could allow residents and business owners the opportunity to escape the floodplain before floodwaters put their lives and those that work to protect them at risk.

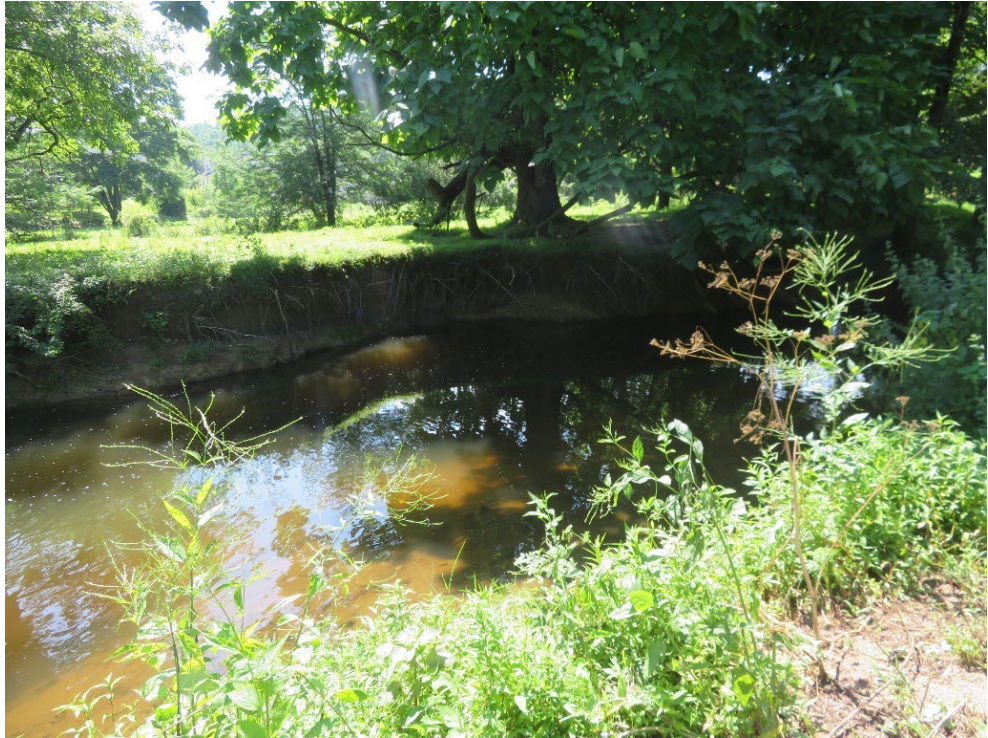
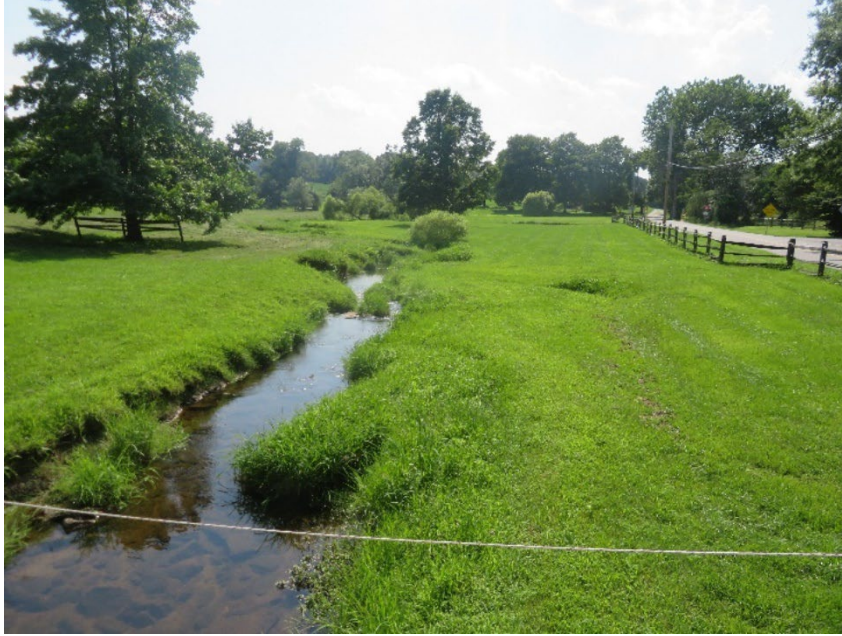
Impacted Stream Segment #12-13:

This high priority stream segment includes a pasture where livestock have direct access to the Upper East Branch White Clay Creek. Approximately 30% of the streambanks in this section of the stream are actively eroding and average four feet high. Where livestock routinely cross the stream, the banks are raw and eroding. At the downstream end of this section, the stream drains under the Third Street bridge.

Restoration of this area should focus on floodplain restoration, streambank stabilization, streambank fencing, and riparian buffer enhancement. Stable ford crossings should be installed at appropriate locations for the livestock to cross the stream without further degrading the steam channel. Native trees and shrubs should be planted within the riparian zone to help the buffer become established. When the Third Street bridge is replaced at some point in the future, the design process should include investigating ways to expand the waterway opening and eliminate piers that contribute to potential channel blockages.

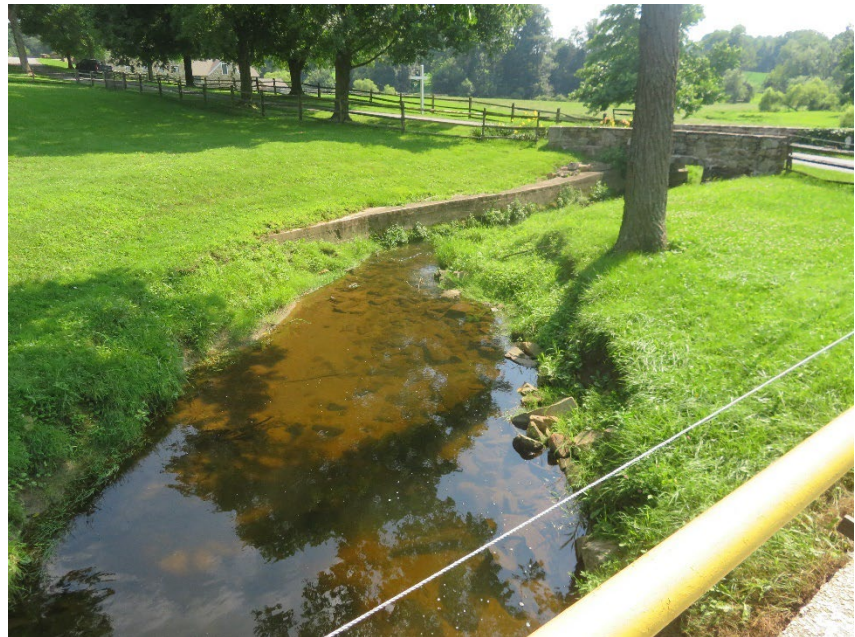
Impacted Stream Segment 35-37:

Within this stream section, the riparian zone is mowed to the edge of the stream. In large sections of the reach, the streambanks are 2-3' high and actively eroding. In a portion of the stream segment, livestock have access to the stream. When livestock are allowed uncontrolled access to a stream channel, they typically contribute to erosion of the streambanks, increase the nutrient loading of the

channel, and can directly increase the amount of fecal coliform bacteria in the water making it unsafe for downstream users.

Restoration of this stream segment should include grading the streambanks to a 4:1 or flatter slope and stabilizing the streambanks with a combination of native plantings and instream log or rock habitat structures. Grading the banks to a stable slope will improve the filtering of pollutants in the riparian zone by increasing the surface area of the contact zone between riparian vegetation and pollutants being transported by the stream during high flow events. In areas where livestock have access to the creek, streambank fencing, stable livestock ford crossings, rotational grazing, and other agricultural best management practices should be implemented. After the streambank fencing is installed, the riparian buffer should be planted with native trees and shrubs.

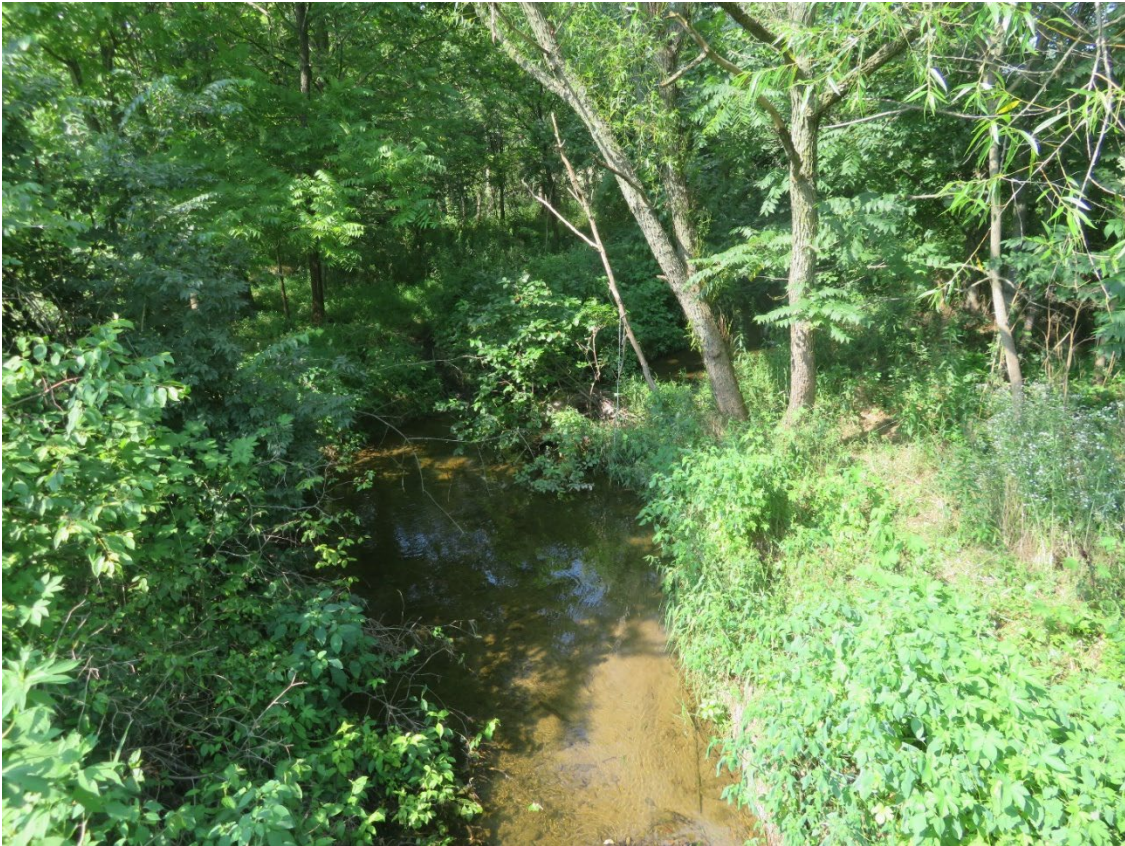
Impacted Stream Segment #43:

The unnamed, headwaters stream (Tributary 00455) that flows through this point is primarily forested with mostly stable streambanks. During the watershed assessment phase, the sample point in the headwaters of this unnamed tributary had the highest macroinvertebrate score in the watershed. While many of the parcels in this section of the watershed already are covered under conservation stewardship agreements, additional work to seek easements and protect the water quality of this section of the watershed remains as there are several unprotected parcels that contribute stormwater and pollutants to the stream channel and threaten the continued integrity of the riparian buffer.

Natural Lands, Brandywine Conervancy, and Stroud Water Research Center have been leaders in reaching out to landowners, identifying shared goals, and securing lasting conservation stewardship agreements throughout the watershed. This study reaffirms the importance of these conservation stewardship agreements and adds a particular focus to the sub-watershed that drains to Tributary 00455 as it provides the highest water quality in the Upper East Branch Red Clay Creek Watershed and is a refuge for sensitive aquatic life within this exceptional value watershed. For those conservation stewardship agreements that are already in place, it is important to complete routine site visits to ensure the goals and conditions of the easements are being upheld.

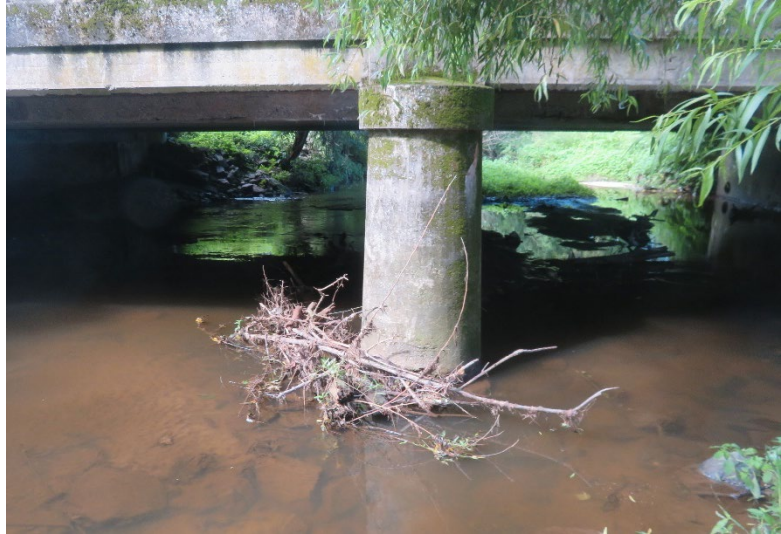
Impacted Stream Segment #5:

At this location, the Gap Newport Pike crosses the East Branch White Clay Creek. The existing bridge has a center pier that catches debris and contributes to the formation of a gravel bar just downstream of the bridge. The pier and gravel bar increase the potential for channel blockage during high water events and increase the risk of flooding for the upstream community.

The gravel bar and any debris on the central pier of the bridge should be removed as part of routine maintenance by PennDOT. Avondale Borough should monitor the bridge for blockages and notify PennDOT if maintenance is required. When the bridge is replaced at the end of its service lifetime, the replacement structure should be a single span bridge if feasible as that would greatly reduce the risk of blockage.

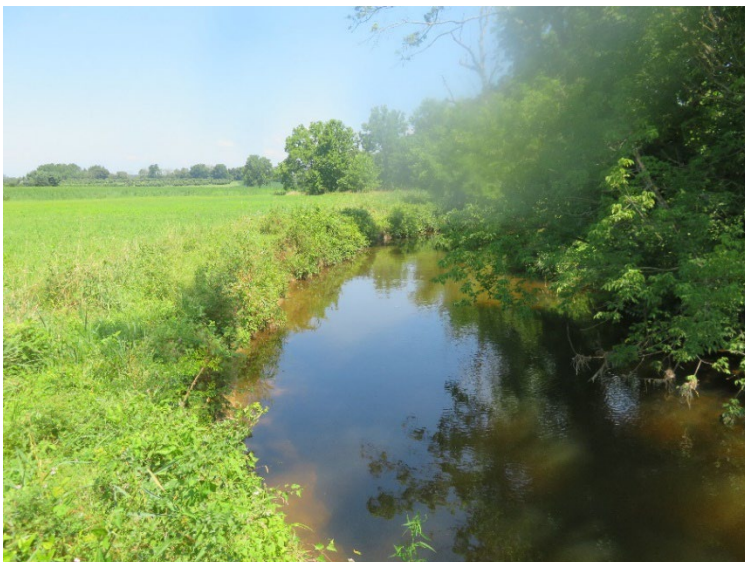
Impacted Stream Segment #15-17:

Within this section of stream, active agricultural fields extend to within ten feet of the top of the streambanks. Legacy sediment from farming before conservation practices were standard has buried the pre-colonial floodplain and stream system so that the current channel is steeply incised. The streambanks are 4-5' high and are actively eroding in portions of the stream segment.

Floodplain restoration is key to repairing this impacted stream segment. The removal of legacy sediment could allow for construction of an active floodplain with wetland pockets to aid in attenuating flooding and pollutants moving through the watershed. Streambank stabilization, instream structures, and riparian buffer plantings could aid in creating a more resilient stream and riparian zone.

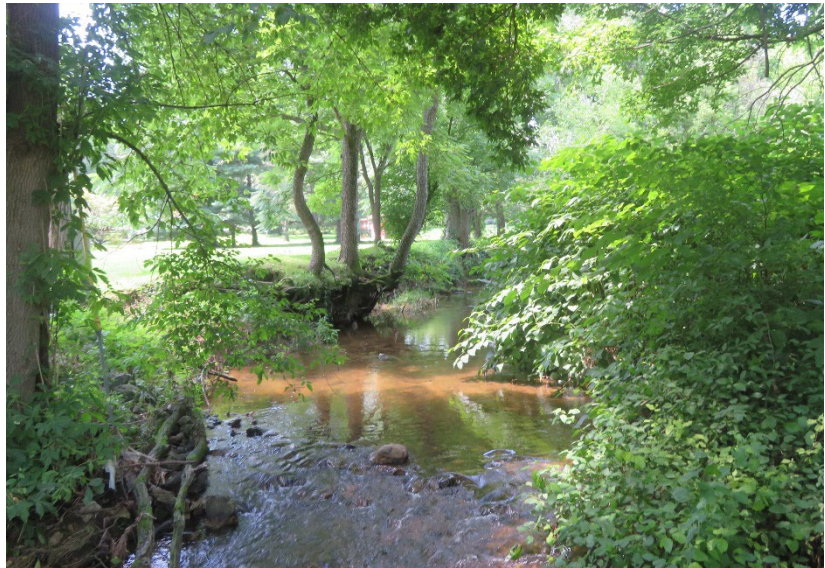
Impacted Stream Segment #27-28:

Within this section of stream, the streambanks are actively eroding and are 3-4' high. The riparian zone is mowed to the streambank on the western side and dominated by the invasive Japanese knotweed (*Reynoutria japonica*) on the eastern streambank.

Restoration of this area should include floodplain restoration that focuses on removal of legacy sediments and reconnecting the floodplain, streambank stabilization, installation of instream habitat structures, invasive species removal, and riparian buffer enhancements.

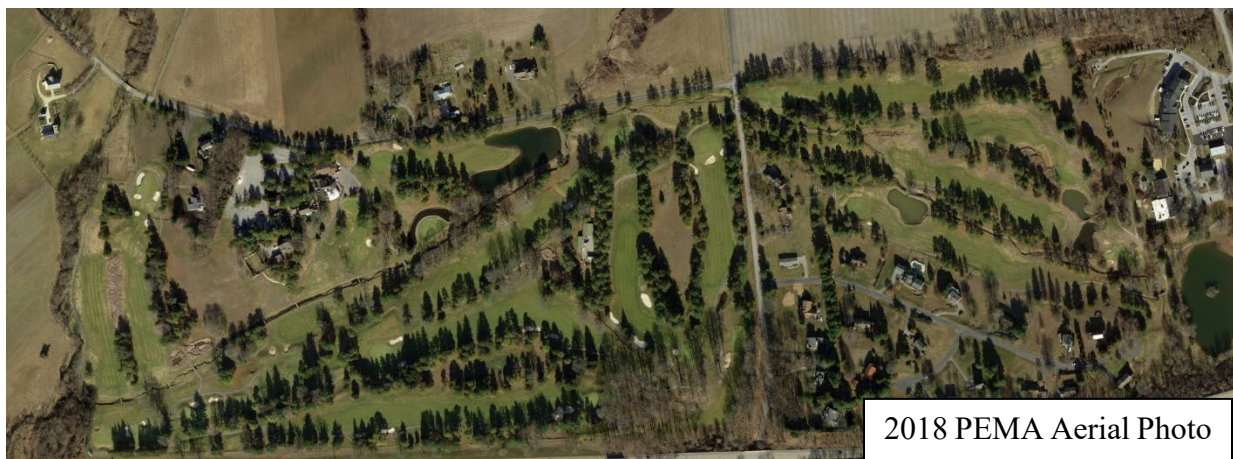
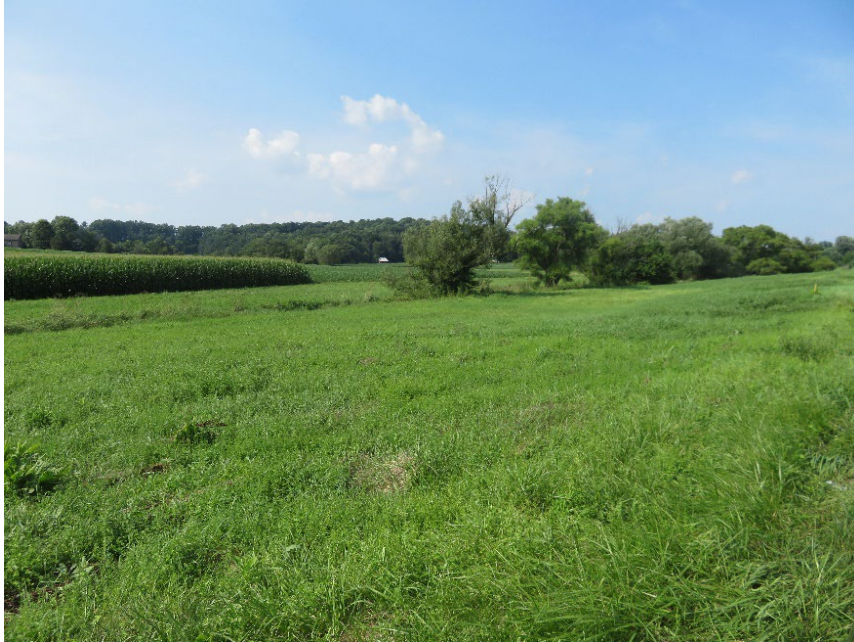
Impacted Stream Section 47-49:

This stream section flows through the former Loch Nairn Golf Club. The club was recently acquired as a passive recreation park by New Garden Township. A legacy of impacts from the golf club remain on the property. The legacy impacts include mowed riparian zones, residual fertilizers and pesticides, and many areas dominated by non-native species.

The site is being converted from a traditional golf course to a naturalized, passive recreation area. The restoration of this stream segment should include retentive grading and wetland cells to decrease flooding flows to downstream areas, native riparian buffer and upland plantings, and implementation and retrofits of stormwater management areas. Natural Lands and Stroud Water Research Center are working with New Garden Township to develop the park under the guidance of a site master plan.

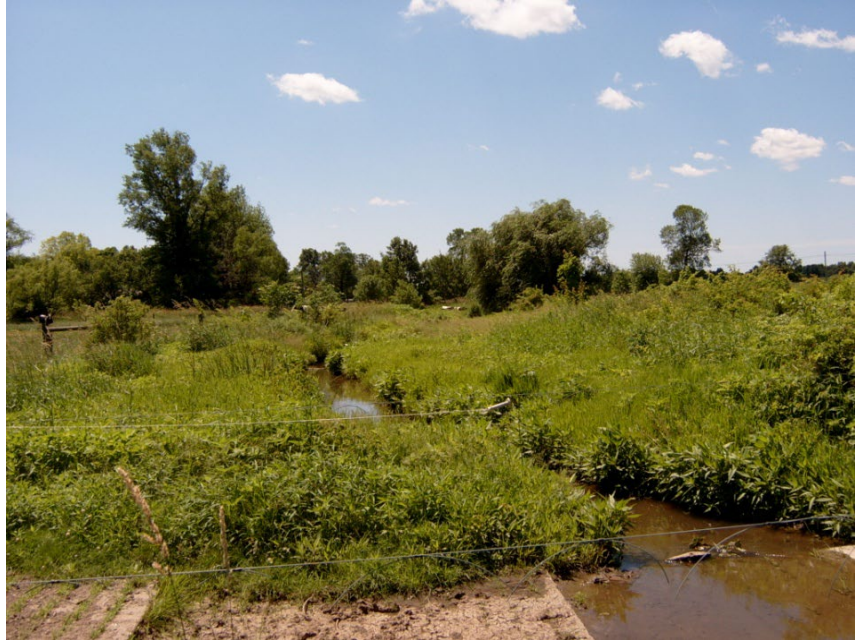
Streambank Fencing

Restricting livestock access to streams and wetlands contributes to herd health, improves wildlife habitat, improves water quality, and makes the water safer for those coming in contact with it. Streambank fencing typically consists of either single strand (adult cattle only) or double strand electric fencing. The fence is located as far back from the streambank as practical and installed parallel to the flow of the stream. Installation assistance is often available. The landowner is typically responsible for maintaining the fence. While livestock often graze the area under the fence, it is sometimes necessary to mow to control vegetation from shorting the fence. Streambank fencing is often coupled with stabilized ford crossings so livestock can access pasture areas on the opposite bank of the stream.

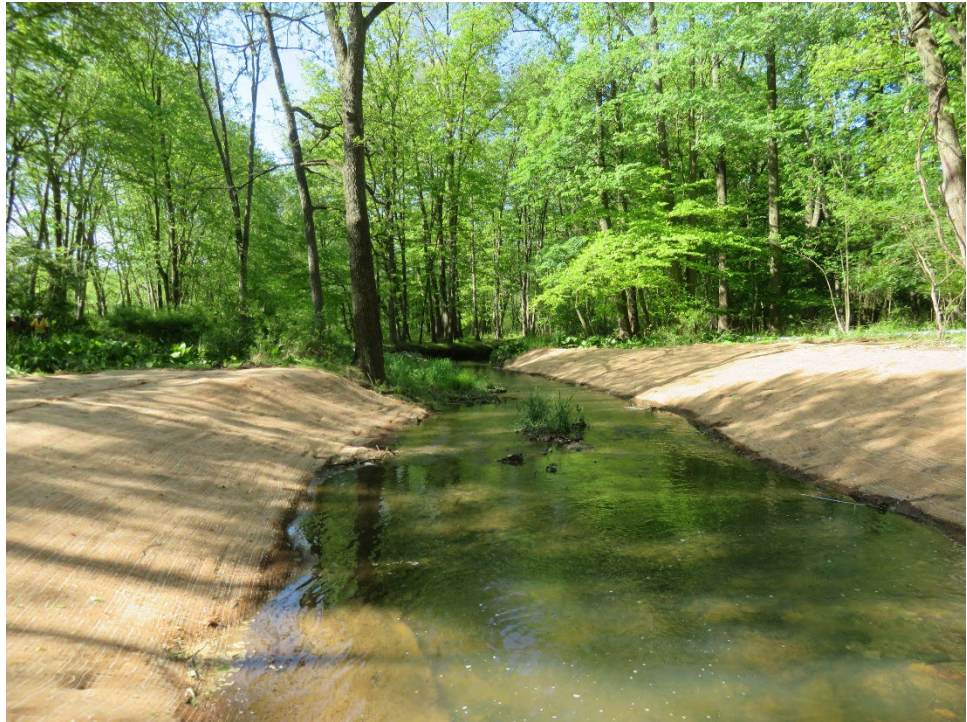
native vegetation is often the best long-term option. As the vegetation becomes established, a combination of log and rock structures are often implemented to aid stabilization. The use of well positioned in-stream deflectors, cross-vanes, j-hooks, and straight vanes can help to hold the streambanks in place as the vegetation becomes established. These structures, when utilized effectively, minimize streambank erosion by reducing the force of water that is scouring the bank surface and provide habitat for many types of aquatic life.

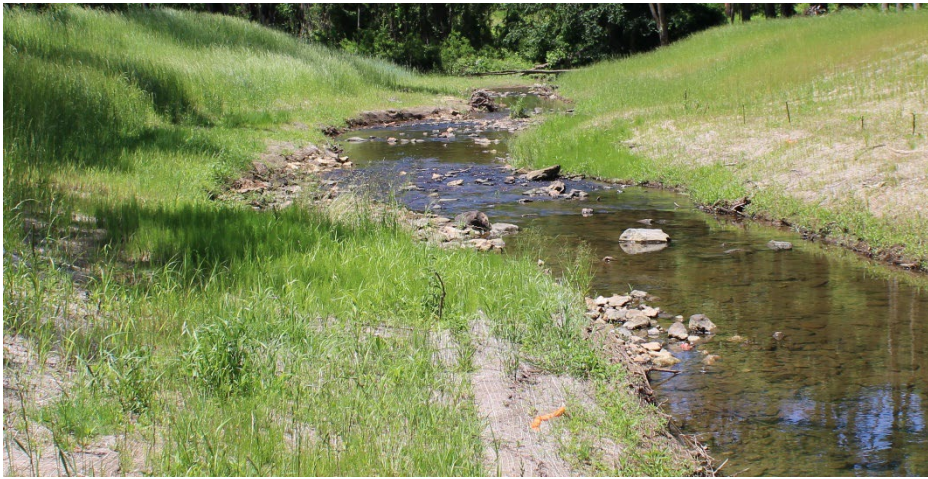
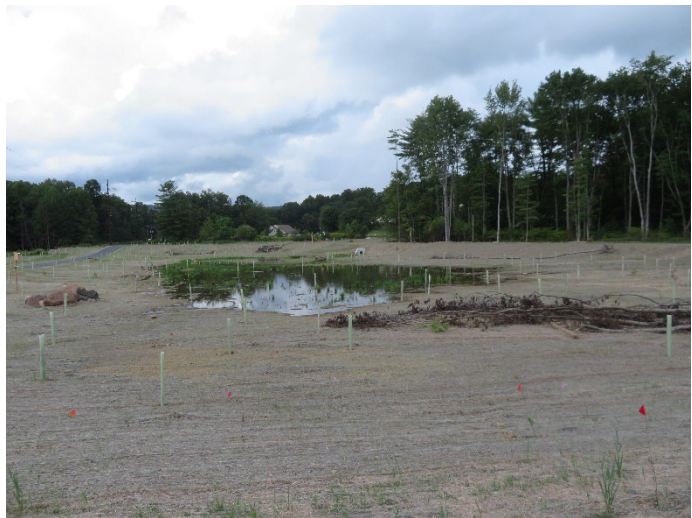
Floodplain Restoration

In many areas of the Upper East Branch White Clay Creek Watershed, past human activities have placed fill in or caused extensive sedimentation within the riparian zone. The excess material along the edge of the stream channel has

disconnected the stream from the floodplain. Floodplain restoration projects are designed to remove excess soil from the floodplain so that the stream is reconnected to an active floodplain. Active floodplains are important to not only reduce the volume and velocity of floodwaters, but also to filter nutrients and pollutants from floodwaters and to provide habitat for a diverse riparian community. The restored streambanks and floodplain area can be planted with native wildflowers, grasses, shrubs, and trees to help stabilize the riparian zone and promote use of the area by a diversity of native wildlife. Floodplain restoration projects can range from establishing a small bankfull bench to help disperse flows to large scale excavation projects that uncover the historic valley floor.

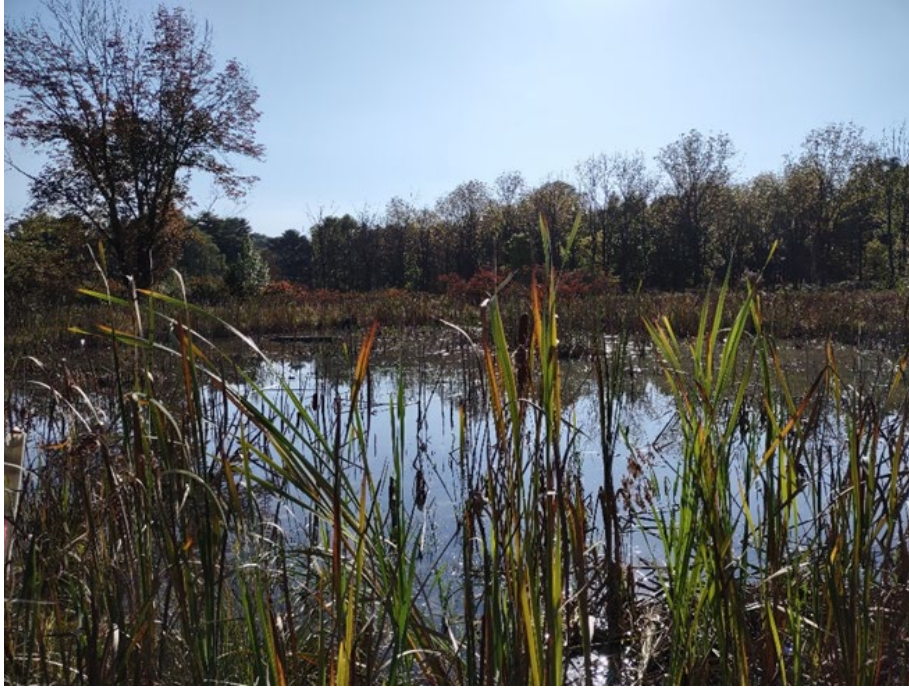
Constructed Wetlands

Throughout the Upper East Branch White Clay Creek Watershed, many areas lack connections to wetlands. Creation of constructed wetlands in the watershed will have multiple positive impacts on the watershed. Foremost, constructed wetlands can serve to remove contaminants and pollutants caused by human activity from the water supply through the same processes of naturally occurring wetlands. These processes help to

remove and break down contaminants. Constructed wetlands not only offer the benefit of water quality improvements through a natural and holistic process, but also provide a variety of niche habitats for local plants and wildlife. Wetlands are considered to be one of the most productive ecosystems on Earth, and provide habitat for birds, mammals, amphibians, and reptiles, as well as

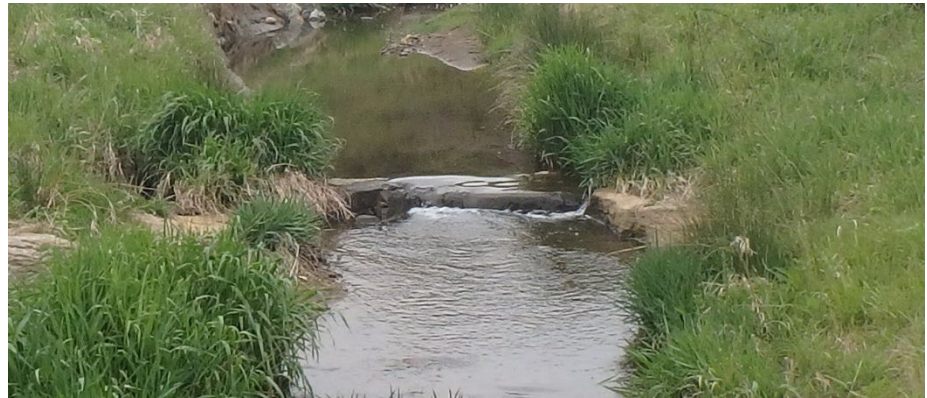
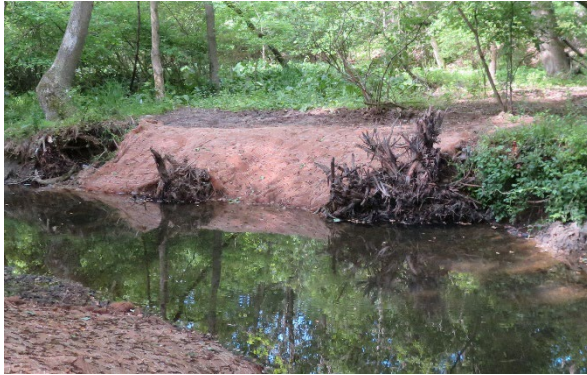
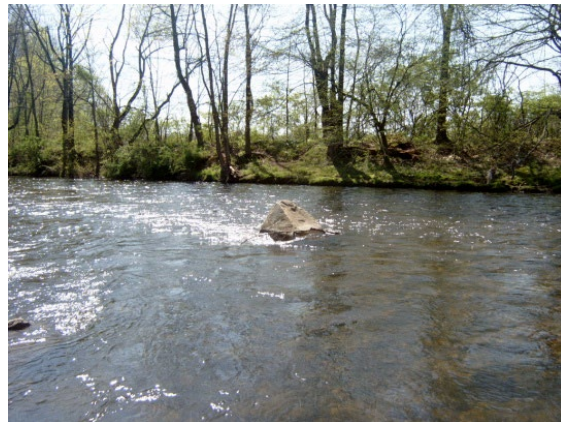
In-stream Restoration Structures

In-stream rock and log deflectors, cross-vanes, j-hooks, and boulder placements are effective tools for creating in-stream fish habitat and aiding in the stabilization of streambanks. The structures are typically constructed based on what materials are available on the site or are locally available.

Root wads from clearing operations may be anchored into the streambanks to slow the flow of water in the stream and create habitat for fish and aquatic life. Log sections may be used to create vanes and deflectors to protect banks and create in-stream habitat. Where needed, boulders can be placed either randomly for fish habitat and to disperse

flows or aligned to roll the stream flow away from the bank and into the center of the channel. In-stream structures are typically designed to manage low to moderate flow conditions and help shape and maintain a natural stream configuration. During high flow events, the structures are designed to stay in place beneath the floodwaters.

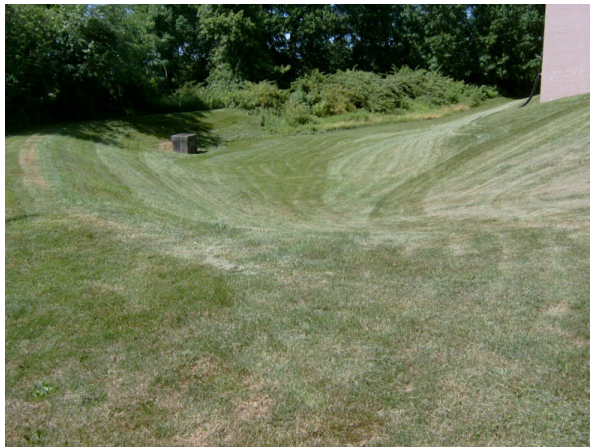
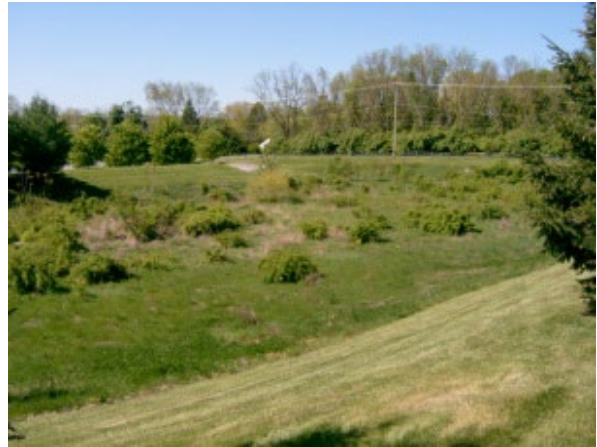
Stormwater Management Retrofits

In order to decrease the impacts of stormwater on the watershed, effective best management practices should be installed with new construction. Where existing stormwater structures exist, they should be evaluated for effectiveness and retro-fitted where necessary.

Common stormwater retrofits focus on improving the function of existing structures so that they more closely reflect the natural hydrological cycle. Within existing stormwater basins, native species may be planted or allowed to become established. Minimizing mowing and labor in this way provides for additional wildlife habitat, reduces nutrient discharges to the stream, and allows for the vegetation to return more of the stormwater to the atmosphere through evapo-transpiration. Other strategies for stormwater retrofits include installing cisterns to allow for water reuse and infiltration trenches to increase the return of stormwater to the groundwater.
